National Transportation Safety Board
Washington, DC 20594

Safety Recommendation Report

Providing Occupant Protection for Limousine Passengers

Accident Number:	HWY19MH001
Location:	Schoharie, New York
Date:	October 6, 2018
Recommendation Nos.:	H-19-14 through -17 and Reiteration of H-15-42 to the state of New York
Adopted:	September 13, 2019

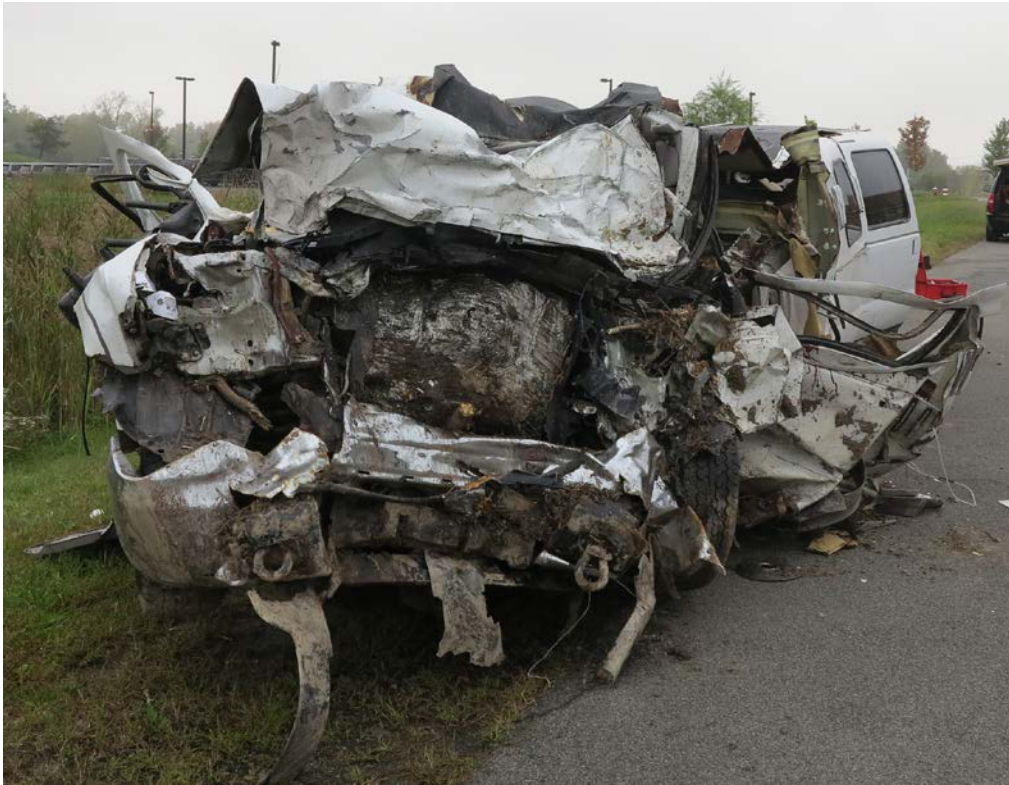
As a result of the impacts with the SUV and the embankment, the limousine sustained severe damage to its front end, with greater deformation to the driver's side (see figures 1 and 2). Overall, the left front of the vehicle was displaced rearward by about 60 inches, and the left wheel was moved about 49 inches rearward. The engine was pushed down and rearward toward the driver's footwell, and the steering wheel was pushed rearward and up toward the vehicle roofline. Survival space was compromised for the driver and front passenger areas.⁴ Despite the severe damage and intrusion, rear portions of the passenger compartment remained relatively intact, maintaining space for the occupants to survive.

Figure 1. Postcrash front view of the 2001 Ford Excursion limousine (not in the crash final rest position).

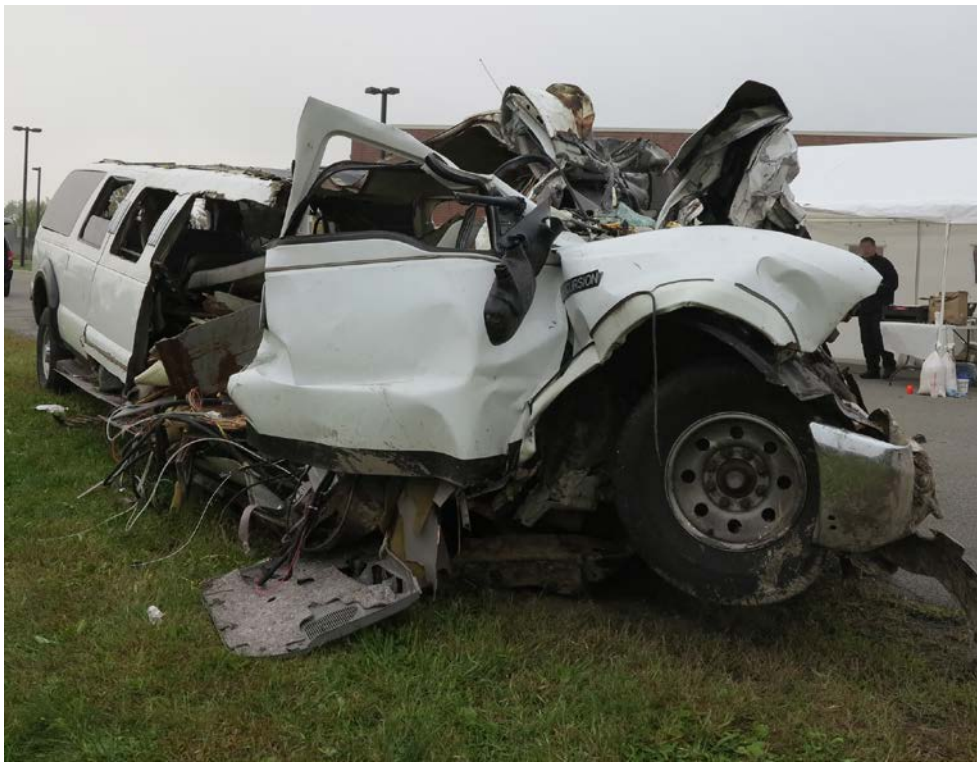
Figure 2. Postcrash passenger side view of the 2001 Ford Excursion limousine (not in the crash final rest position).

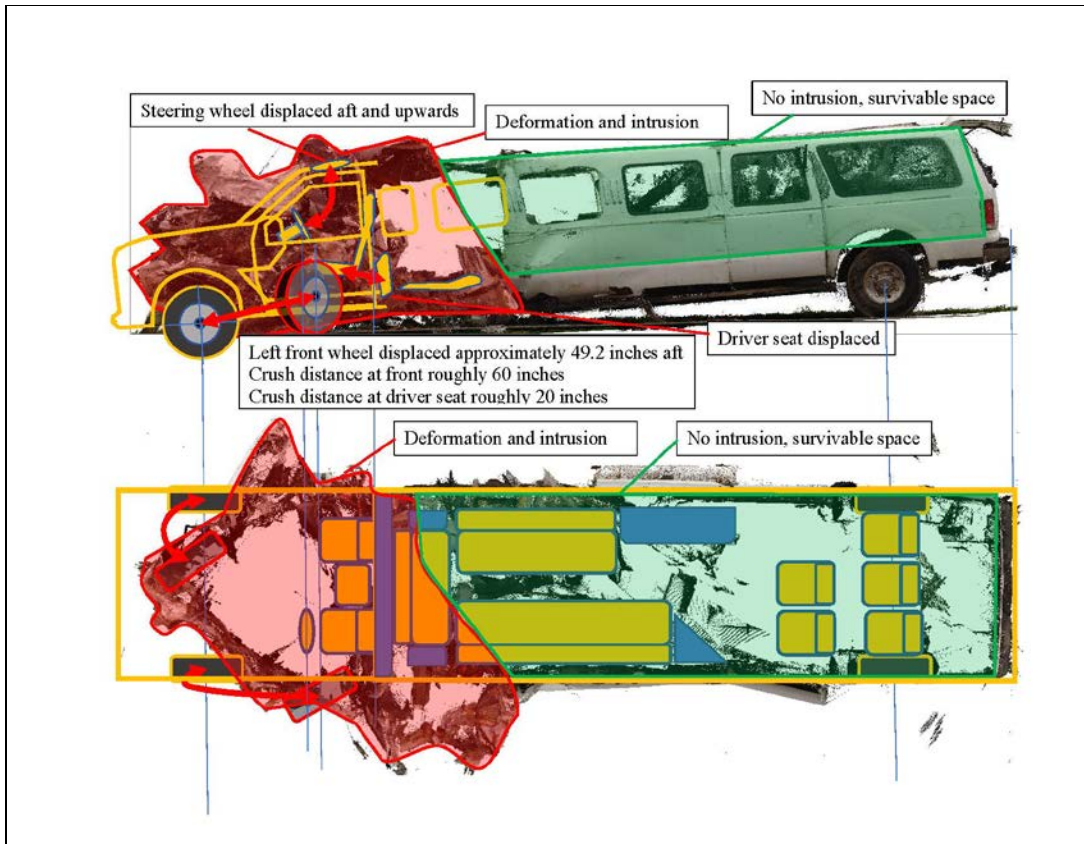
This crash resulted in the complete loss of occupant survival space for the driver and front passenger seats, and partial intrusion into the left front corner of the passenger compartment. Figure 5 shows a driver-side and overhead view of the limousine created by 3D scans of the vehicle, with line drawing overlays. The overhead scan uses a “slice” just above the floor of the vehicle. The line drawings of the front of the limousine were reconstructed from drawings provided by Ford Motor Company and estimates of the limousine’s precrash dimensions. Portions of both views have a yellow outline that roughly represents the original structure of the limousine before the crash. The red-shaded areas represent the approximate region of intrusion and compromised survival space. The green-shaded areas highlight the portion of the limousine that remained relatively intact and where survival space was maintained.

The limousine driver was wearing his lap/shoulder belt at the time of the crash and his air bag deployed; however, the driver’s compartment had a complete loss of survival space. Therefore, the NTSB concludes that the crash was not survivable for the limousine driver. There was also intrusion into the passenger seats immediately behind the privacy divider. Specifically, the passengers seated in these rear-facing seats and in the forward portion of the side-facing bench seat on the driver’s side (a portion of the red-shaded areas in figure 5) were at risk of fatal injuries from intrusion and the vehicle crush that compromised the driver’s compartment. A large portion of the limousine’s passenger compartment, identified in the green-shaded areas of figure 5, was not compromised by intrusion and retained survival space.

Figure 5. Top image shows side view postcrash 3D image of the limousine with an overlaid reconstruction of the vehicle's precrash structure. Bottom image shows overhead view of postcrash 3D image of the limousine with an overlaid reconstruction of the vehicle's precrash structure.

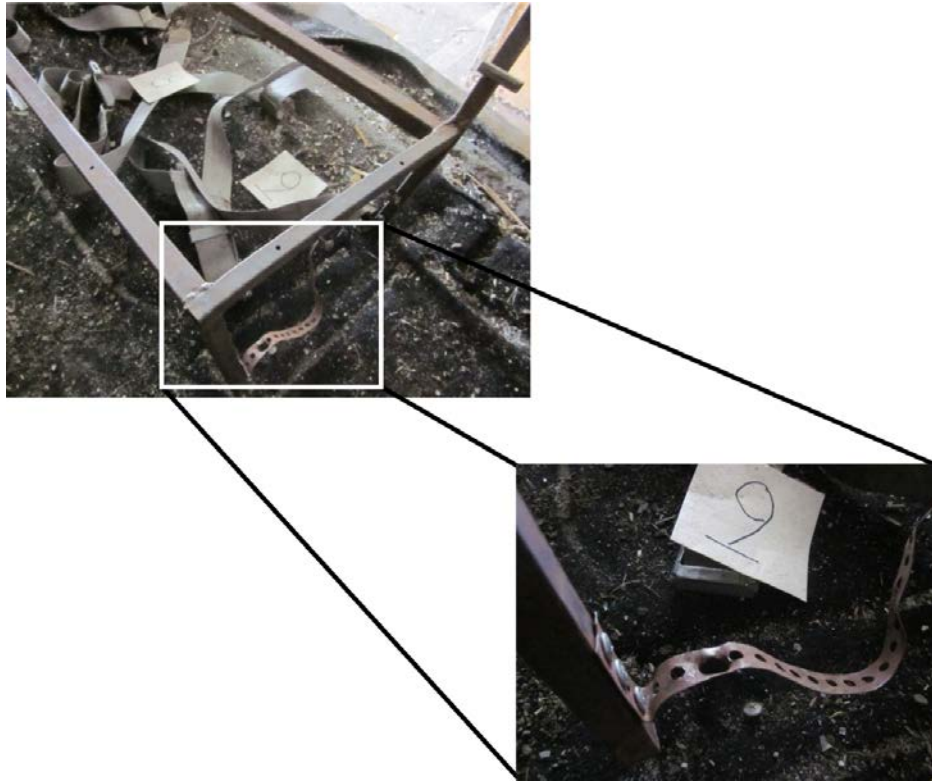
Seat Integrity. Postcrash examination of the limousine’s non-OEM bench seats showed that the seat frames were constructed from welded square tubular steel and were attached to the floor using individual screws that were mounted through the metal seat anchor straps.¹⁵ During the crash sequence, the side- and rear-facing bench seats failed in the direction of the crash forces. The seat cushions separated from the seat frames, and the seat frames separated from their anchorage points, collapsed, and were displaced forward toward the passengers and the privacy divider.¹⁶ The mounting holes in the seat frame anchor straps were elongated, which released the screws that anchored the seat straps to the floor. (See figure 6.) Therefore, the strength of the non-OEM side- and rear-facing bench seats and their anchorages was inadequate to keep them secured to the floor during the collision, even without the additional loading that would have occurred with belted passengers. In contrast, the rear OEM seats remained attached to the floor and intact, despite experiencing some damage.¹⁷ (See figure 7.)

¹⁵ The anchor straps appeared to be made from commonly available, thin steel, pipe-hanging strap. The installation of the bench seat frame and anchorage was not consistent with the methods used for the dynamic load environment of a motor vehicle.

Figure 6. Right-side bench seat frame, with a closeup view of the damage to the seat frame anchor strap.

Require that seating systems installed in new vehicles modified to be used as limousines meet minimum performance standards to ensure their integrity during a crash. (H-19-15)

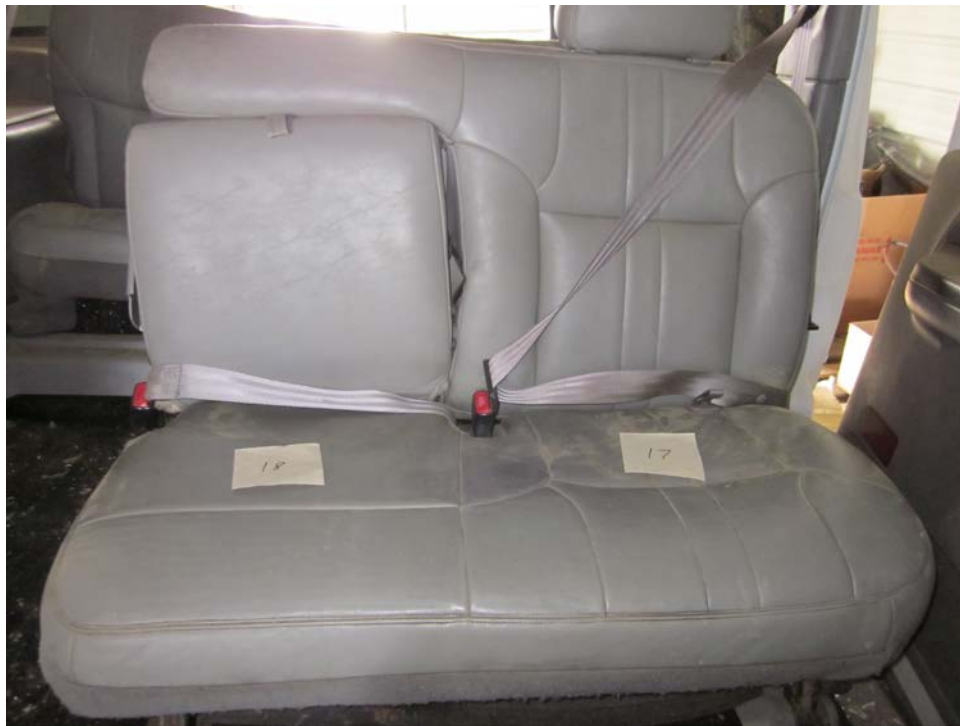
¹⁷ Both the OEM and non-OEM seats sustained deformation from being struck by the unrestrained passengers, and the last row of OEM seats sustained damage from being struck by a vehicle battery stored in the cargo compartment.

Figure 7. The rear OEM seats, which were deformed during the crash but remained structurally intact and attached to the floor. (Although the seat belts appear latched in this photograph, they were not found fastened after the crash.)
