**\*RUSS REEVES, CEng., P.E.**  
**CIVIL-STRUCTURAL ENGINEERS**  
NYS Lic. # 063979

August 14<sup>th</sup> , 2022

**Re: Emergency Stabilization-Project Closeout: 143 Montgomery Street, Albany, New York  
(The Former Central Warehouse Building).**

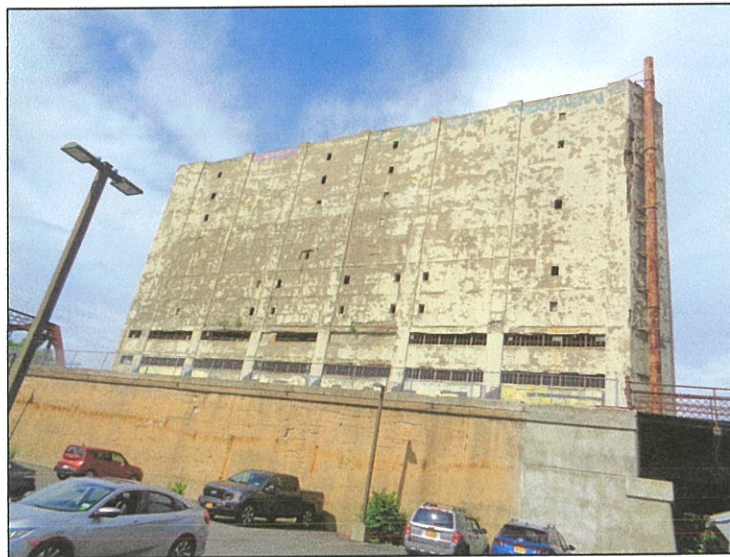
**Photograph 1 (Photo taken July 26<sup>th</sup>, 2022)**  
(South exterior wall-Central Warehouse building prior to implementing emergency remediation measures)

On July 26, 2022, it was noted that concrete masonry had fallen from the upper Southeasterly corner adjacent to the smoke stack of the former Central Warehouse building. This area is more specifically noted in the upper right corner of Photograph 1 with a close-up view shown in Photograph 4.

We responded to the scene and found gross deterioration and spalling about various areas in the South wall, the South parapet wall at the roof level and gross deterioration and section loss in the steel brackets that support the 140' high smoke stack also depicted in Photograph 1. The smoke stack was highly unstable. A collapse of the smoke stack along with additional failure in portions of the loose masonry along the Southerly exterior wall, South parapet wall and Southeast corner of the building were considered imminent at that time.

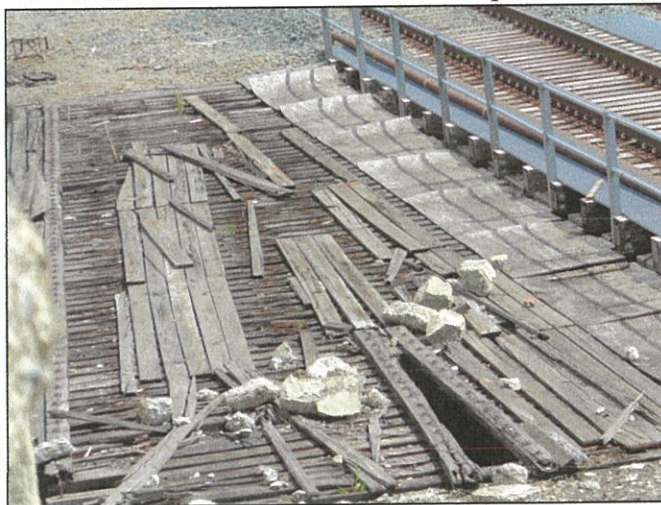
**Photograph 2 –July 26<sup>th</sup>, 2022**

**(Remains of concrete debris that fell from the Southeast corner of the building-adjacent to the Amtrak tracks).**

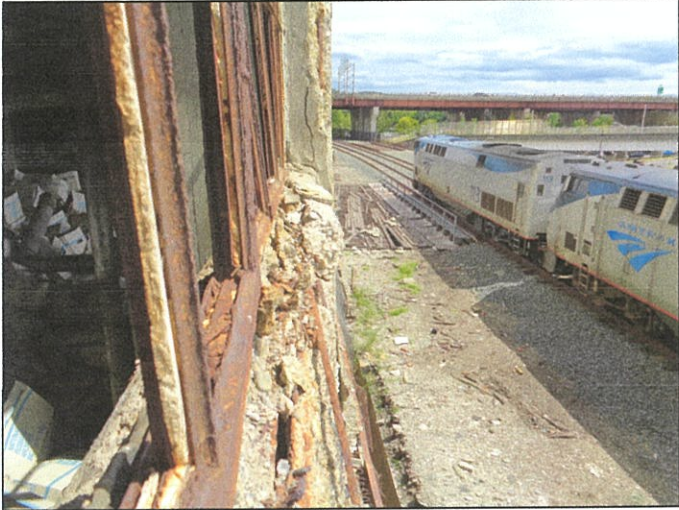
**Photograph 3 – July 26<sup>th</sup>, 2022**  
(Spalling concrete from exterior spandrel beams-adjacent to the Amtrak tracks).

Photograph 3 shows loose and spalling concrete about the large window openings at the third, fourth and fifth floors that have been removed along with the deteriorated and failing wrought iron window frames. Photographs 4 and 5 show the deteriorated and spalling concrete at the Southeasterly corner of the building and at the Southerly roof parapet wall respectively.

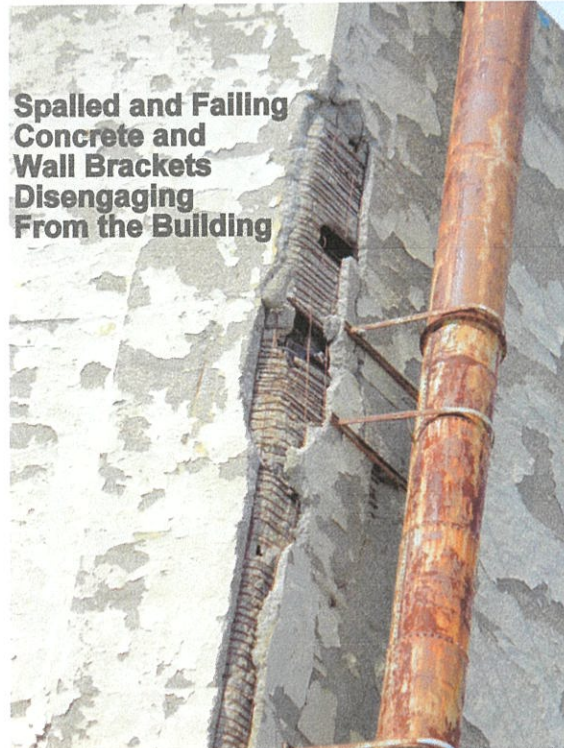
**Photograph 4 – July 26<sup>th</sup>, 2022**  
(Southeast corner of the building)

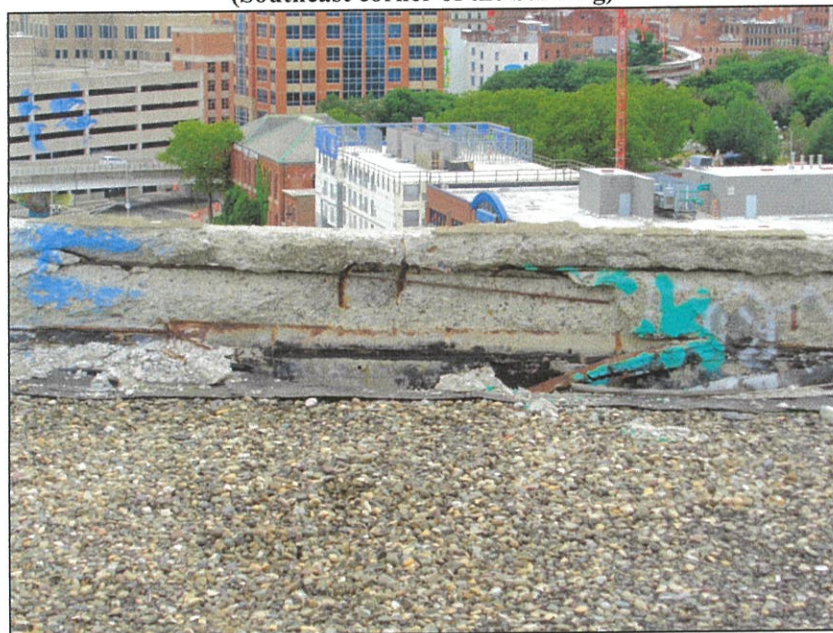
**Photograph 5 – July 26<sup>th</sup>, 2022**  
(Southerly roof parapet wall adjacent to the Amtrak tracks)

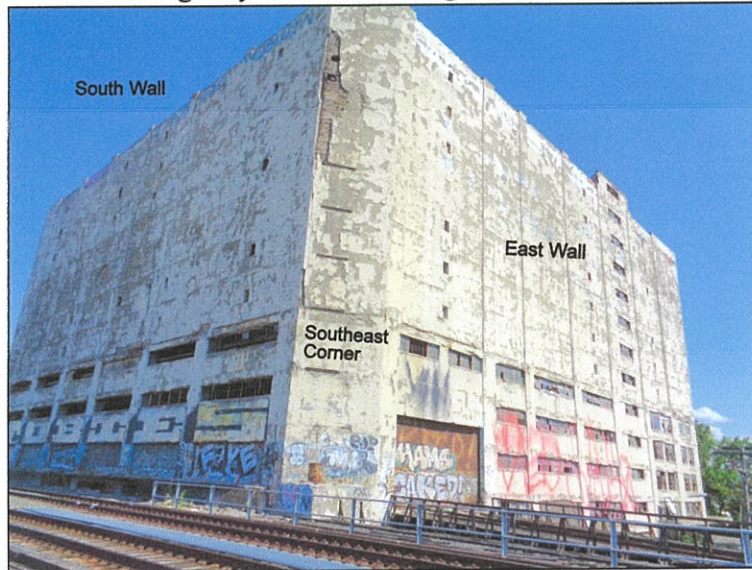
**Photograph 6 -August 1<sup>st</sup>, 2022**

**(Completed -Task 1 removal of all loose & failing concrete and the smoke stack from the Southeasterly corner of the building)**

The 140' high x 3' diameter smoke stack was safely removed from the Southeasterly corner of the building. This is more specifically shown in Photograph 6. All loose fascia wall concrete has been removed from the Southeasterly corner as seen above. The contractor used a pry bar to dislodge all loose concrete from this area. The owner is required to wrap all exposed / spalled concrete areas along the South and Southeasterly side of the building with ice and water shield. This treatment is specific to the spalled area seen in the upper Southeasterly corner section in Photograph 6, as well as around the window area at the seventh floor level fourth bay in from the Southwesterly corner of the building. Strong Man Netting or equivalent (SBN – 1460 Heavy Duty Debris Netting – High Density Polyethylene with a 1/32" mesh openings) shall be placed over the entire Southerly wall, Easterly wall and Southeasterly corner (full height) of the building.

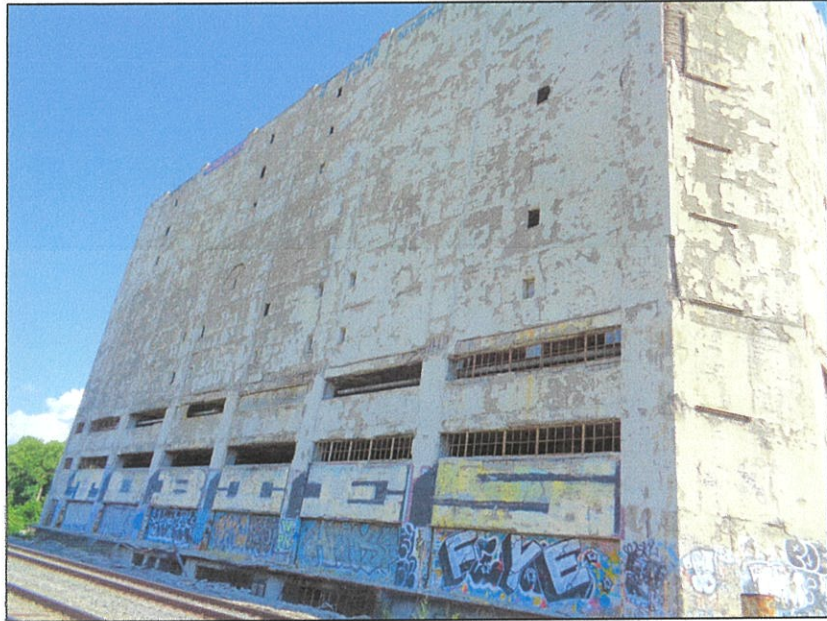
The contractor has satisfactorily removed all loose and spalled concrete from the Southerly side of the building as observed on August 1, 2022. This included visible spalled areas that were loose and all loose concrete about the spandrel beams at the window openings at the fourth and fifth floor level which is more specifically shown in Photograph 7.

**Photograph 7**-August 1<sup>st</sup>, 2022  
(Completed -Task 2 removal of all loose & failing masonry along the Southerly face of the building)

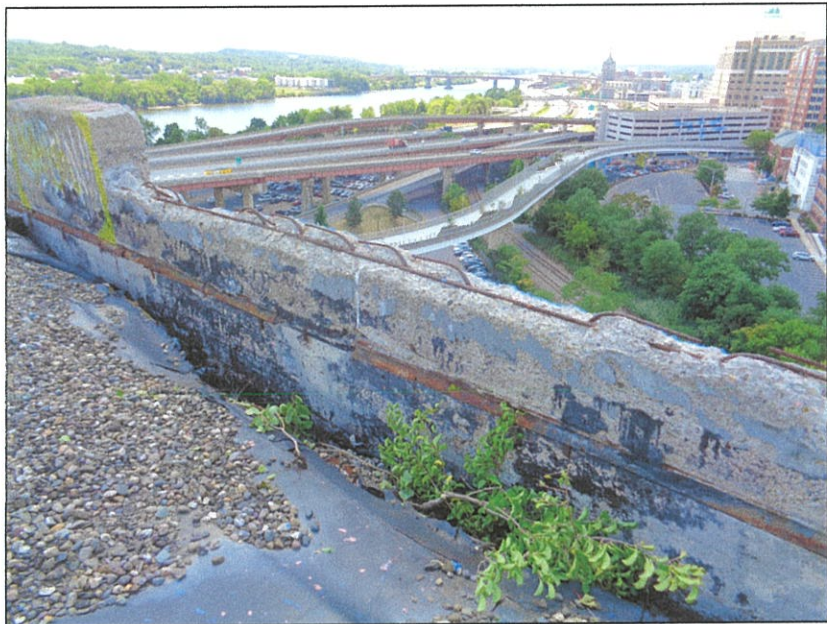
All loose concrete from the Southerly parapet at the roof level as noted on August 1, 2022 has been removed. Please note that due to the deteriorated nature of the perimeter concrete walls and parapet walls, the presence of additional spalled areas could occur at any time. It is the responsibility of the building owner to monitor the condition of the building and make necessary repairs and take the necessary remediation measures in order to maintain public safety.

Photograph 8 shows a typical view of the Southerly parapet wall after loose masonry had been removed.

**Photograph 8** -August 1<sup>st</sup>, 2022  
(Completed -Task 3 removal of all loose & failing masonry along the Southerly parapet wall)

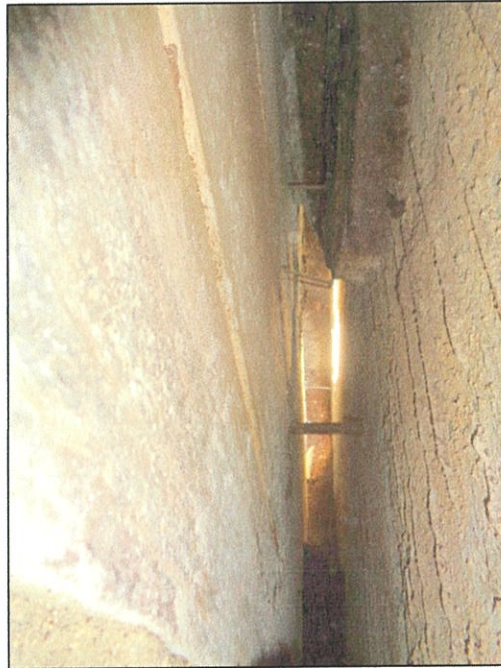
Photographs 9, 10 and 11 are provided to show the condition of the existing wall ties. Photograph 9 shows a wall tie that is separated from the exterior wall at the ninth floor level. Photograph 10 shows wall ties with some concrete spalling. This condition can also be seen in

**Photograph 9 (9<sup>th</sup> floor existing wall ties-typical)**

Photograph 11 which was taken at the eleventh floor level. Each of these conditions are being compensated for with the installation of new wall brackets that are more specifically shown in Photographs 12 through 17.

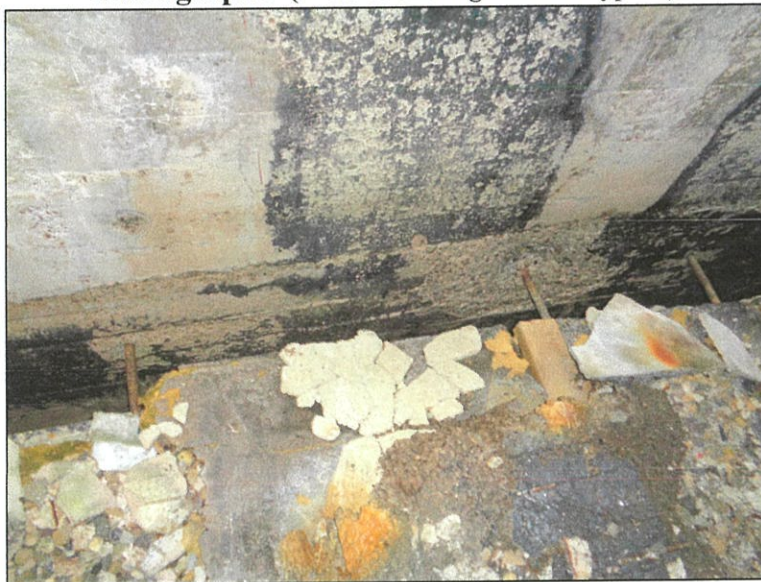
**Photograph 10 – (10<sup>th</sup> floor level existing wall ties)**

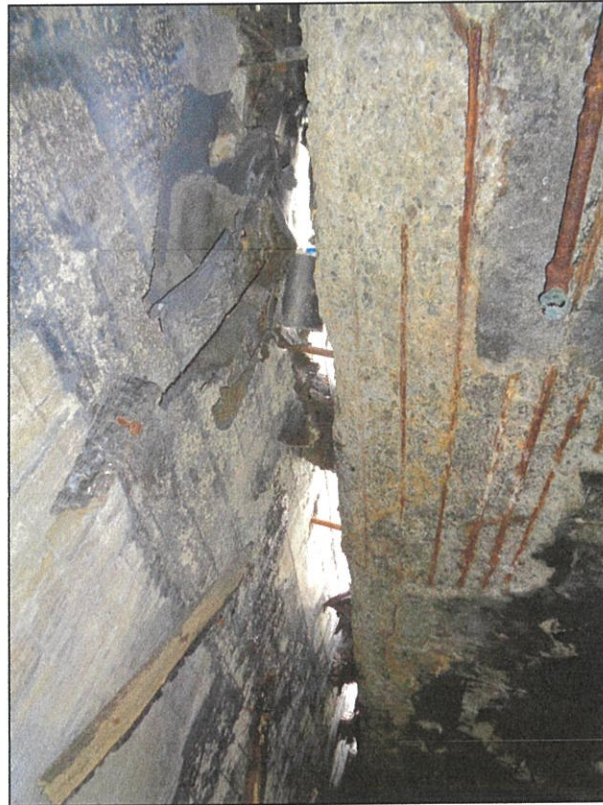
**Photograph 11 – (11<sup>th</sup> floor level existing wall ties)**

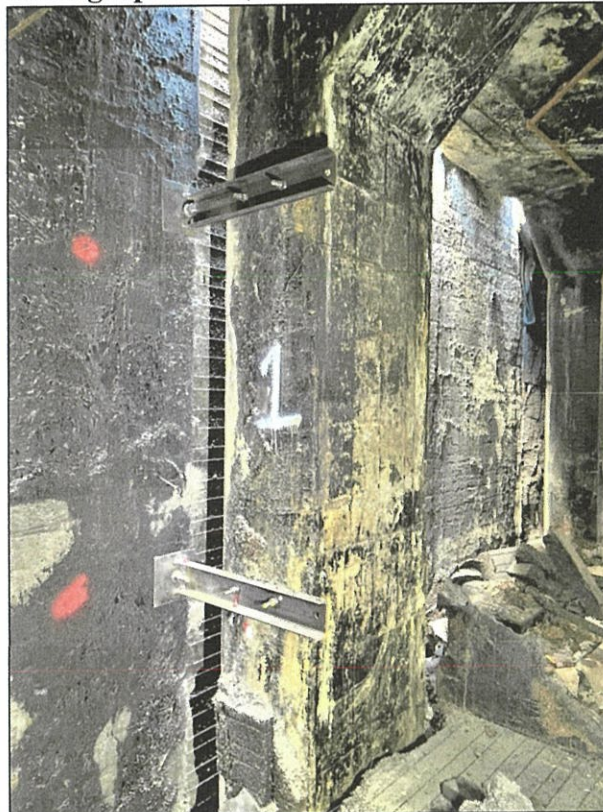
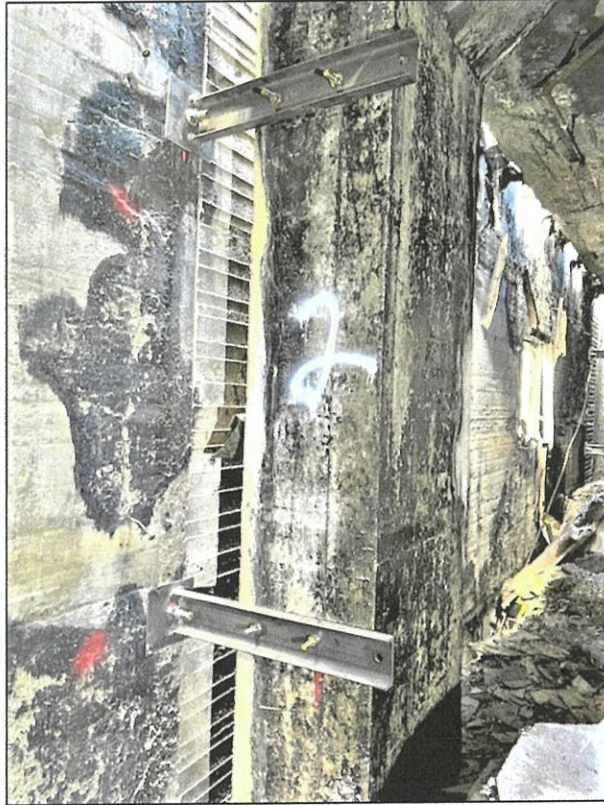
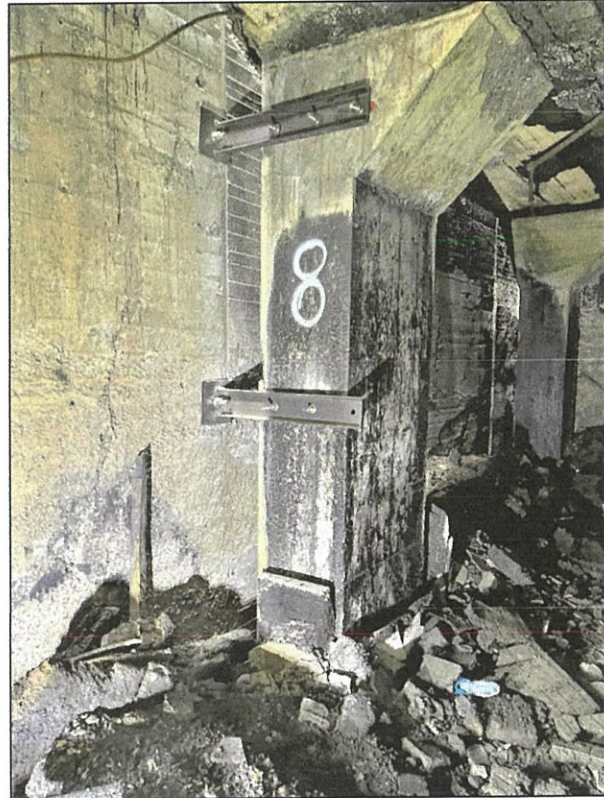
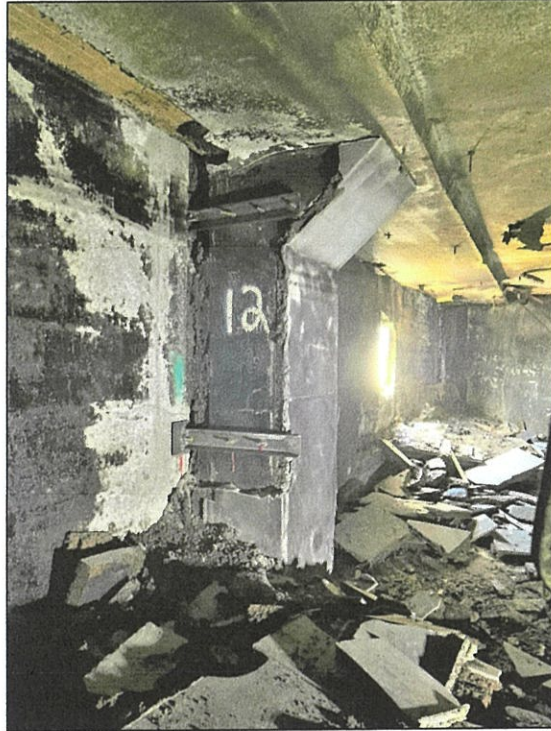
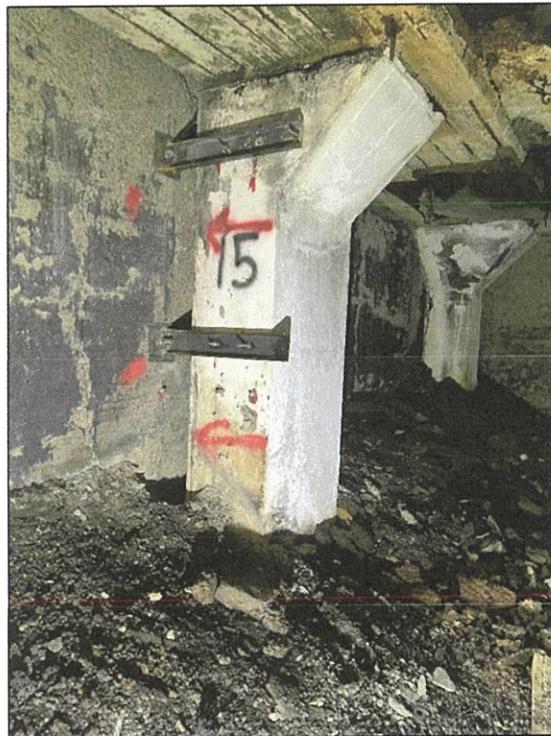
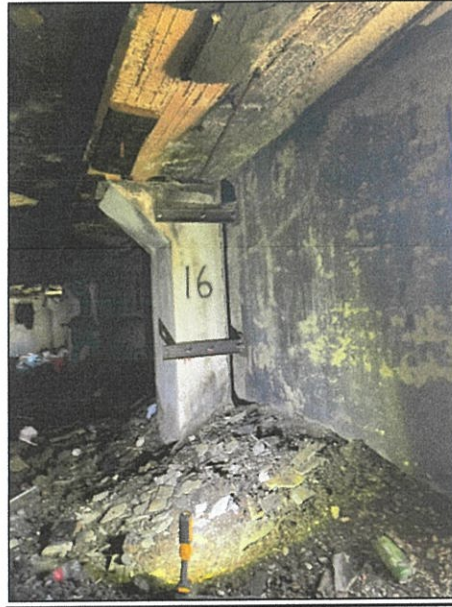
**Photograph 12- (11<sup>th</sup> floor- wall brackets @ column 1)**

**Photograph 13-** (11<sup>th</sup> floor- wall brackets @ column 2)

**Photograph 14-** (10<sup>th</sup> floor- wall brackets @ column 8)

**Photograph 15-** (10<sup>th</sup> floor- wall brackets @ column 12)

**Photograph 16-** (9<sup>th</sup> floor- wall brackets @ column 15)

**Photograph 17-(9<sup>th</sup> floor-wall brackets @ column 16)**

A ¾" diameter A-304 stainless steel threaded rod with Hilti HIT – Re 500 v-3 epoxy adhesive having a 4 ½" embedment into the exterior wall, anchors the exterior wall to a channel bracket that is bolted into the adjacent Southerly wall column. Each bracket is connected to the wall column using 5/8" diameter A-304 stainless steel along with the aforementioned Hilti epoxy adhesive and a 4 ½" embedment into the concrete column.

Please note that the photographs showing the new brackets at floor levels eleven, ten and nine are representative and typical at every floor and are provided for informational purposes to give a level of understanding of what was installed at the upper floor levels to provide supplemental restraint to the exterior curtain wall.
