REPORT OF INVESTIGATION

Fatal Machinery Accident
October 1, 2022

R J Valente Grafton Quarry
R J Valente Gravel
Grafton, Rensselaer County, New York
ID No. 30-03434

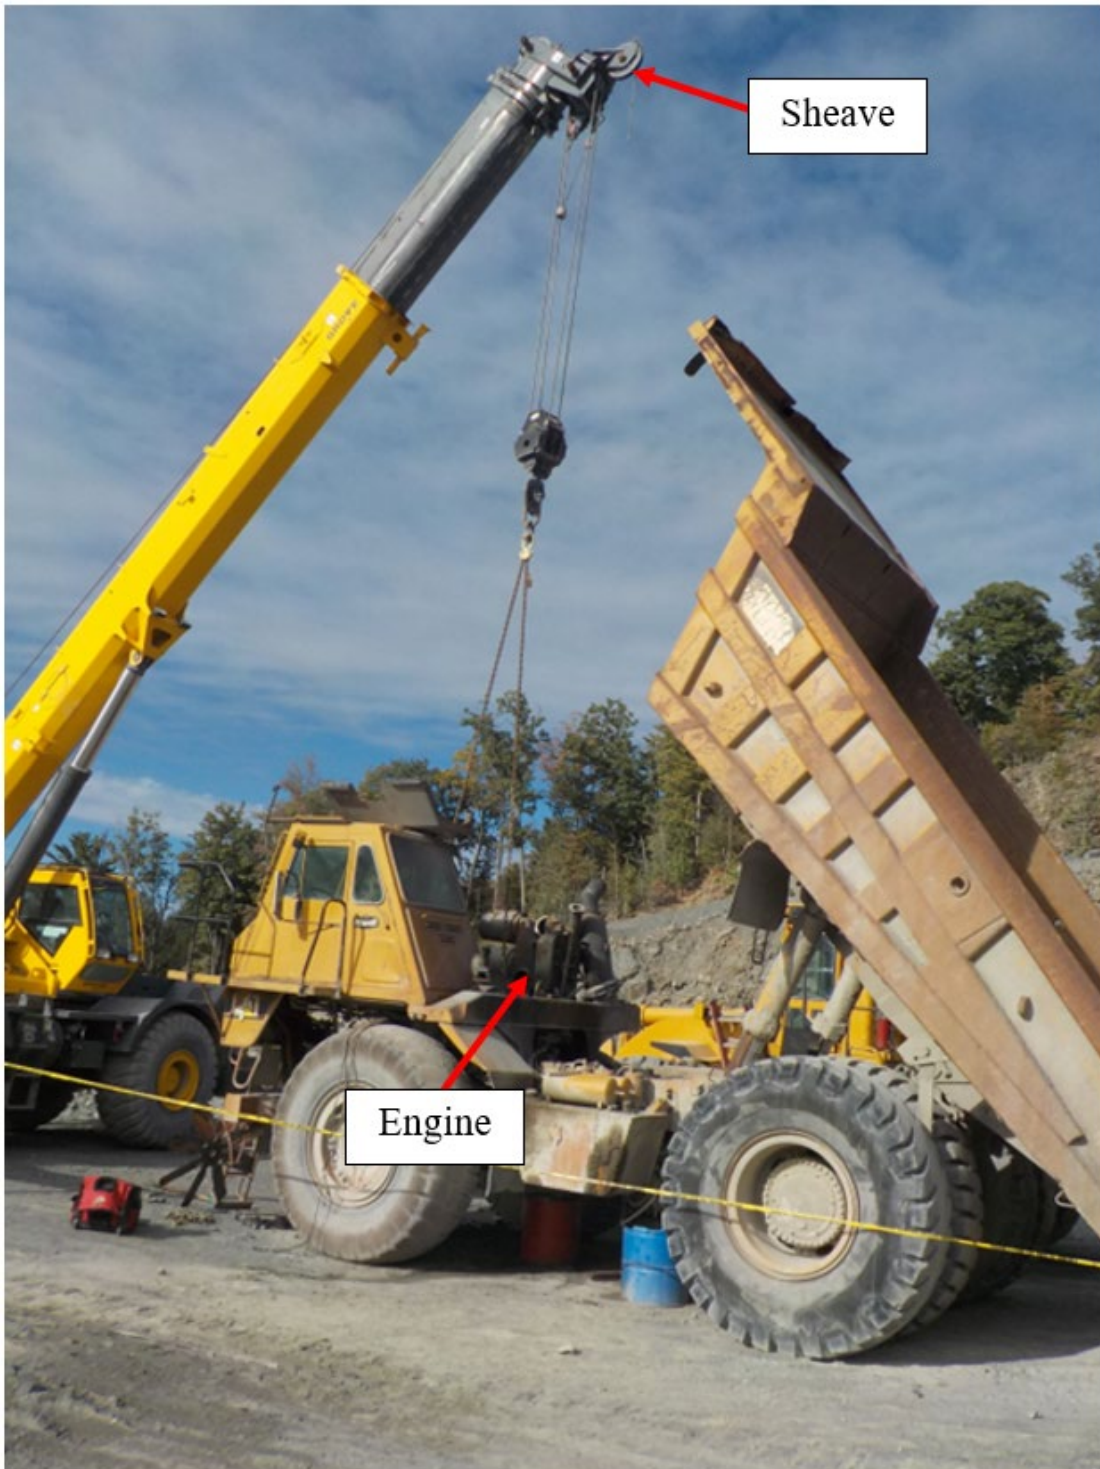
APPENDIX C – Photo of Accident Scene

Miller gave Valente the hand signal to move the crane's boom. When Valente made this adjustment, the overhaul hook ball was pulled up into the sheave, which severed the hoist rope. The overhaul hook ball fell and struck Miller. At 7:55 a.m., Valente called to Miller and received no response. Valente turned off the crane, exited the crane, observed Miller's condition, and ran to Ostrander to inform him of the accident.

The haul truck involved in the accident was a Caterpillar 773B haul truck. Investigators found the crane's overhaul hook ball sitting on the frame of the haul truck. Based on interviews, investigators determined that Miller was standing on the haul truck's frame where the overhaul hook ball was found at the time of the accident. Investigators also determined that the haul truck did not have any defects that contributed to the accident.

Two-blocking is an unsafe condition where the crane's suspended load or loading attachments contact the sheaves at the end of the crane's boom (Appendix C). This can occur by raising the hoist past its upper limits or by telescoping the crane boom without releasing enough hoist line to compensate for the additional boom length. Two-blocking can cause damage to the hoist line and sheaves because the hydraulic power of the crane can exceed the material strength of these components. Failure of the hoist line causes the suspended load to fall.

Corrective Action: The crane involved in the accident was permanently removed from service. The mine operator developed and implemented a new written procedure for out of service criteria of mobile equipment. All miners were trained in this new procedure.
