National Transportation Safety Board
Washington, DC 20594

Safety Recommendation Report

Providing Occupant Protection for Limousine Passengers

Accident Number:	HWY19MH001
Location:	Schoharie, New York
Date:	October 6, 2018
Recommendation Nos.:	H-19-14 through -17 and Reiteration of H-15-42 to the state of New York
Adopted:	September 13, 2019

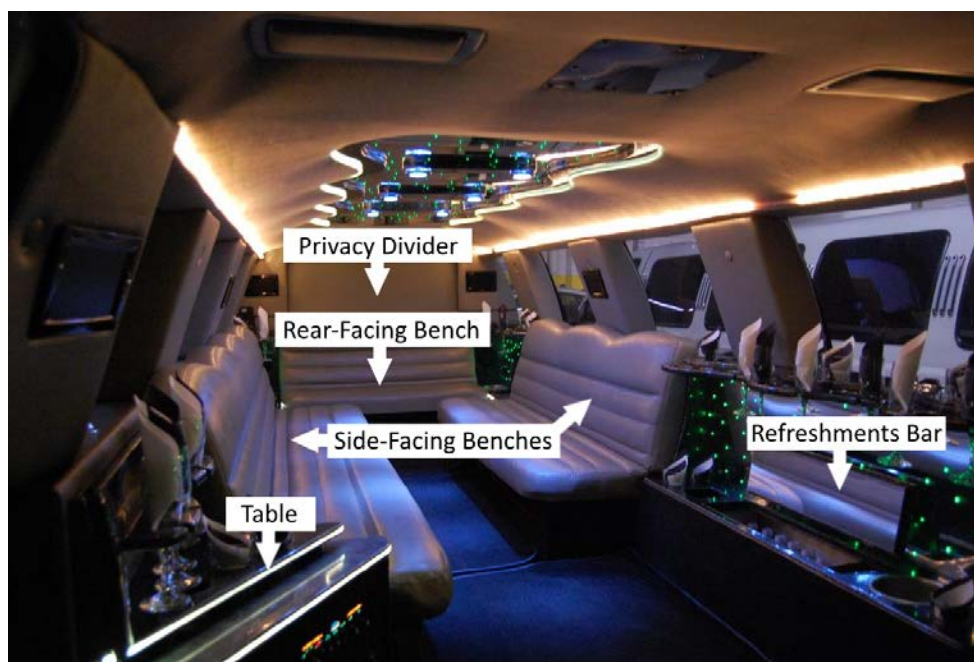
The driver and front passenger seats provided by the OEM were retained, as well as five of the six rear OEM passenger seats. A privacy divider was added between the driver's seat and the passenger compartment. In the stretched portion of the vehicle, a rear-facing bench seat was added, abutting the privacy divider and facing into the passenger compartment (see figure 3). In addition, side-facing bench seats were installed along each side of the compartment, forming a perimeter seating layout (see figures 3 and 4). The side-facing bench seat on the passenger side was shorter than the one on the driver side, and a refreshments bar was installed next to this bench seat and forward of the passenger-side rear door. A small table was also added next to the driver-side side-facing bench seat. The back of the limousine consisted of five Excursion OEM rear seats that faced forward (see figure 4). The OEM seat next to the rear door on the passenger side was removed to allow access to the rear of the passenger compartment.

Figure 3. A 2010 photograph of the limousine's interior, looking from the rear of the passenger compartment toward the driver's compartment. The view to the driver's compartment is blocked by a white privacy divider. (Courtesy of the vehicle's previous owner, Advantage Transportation Group)

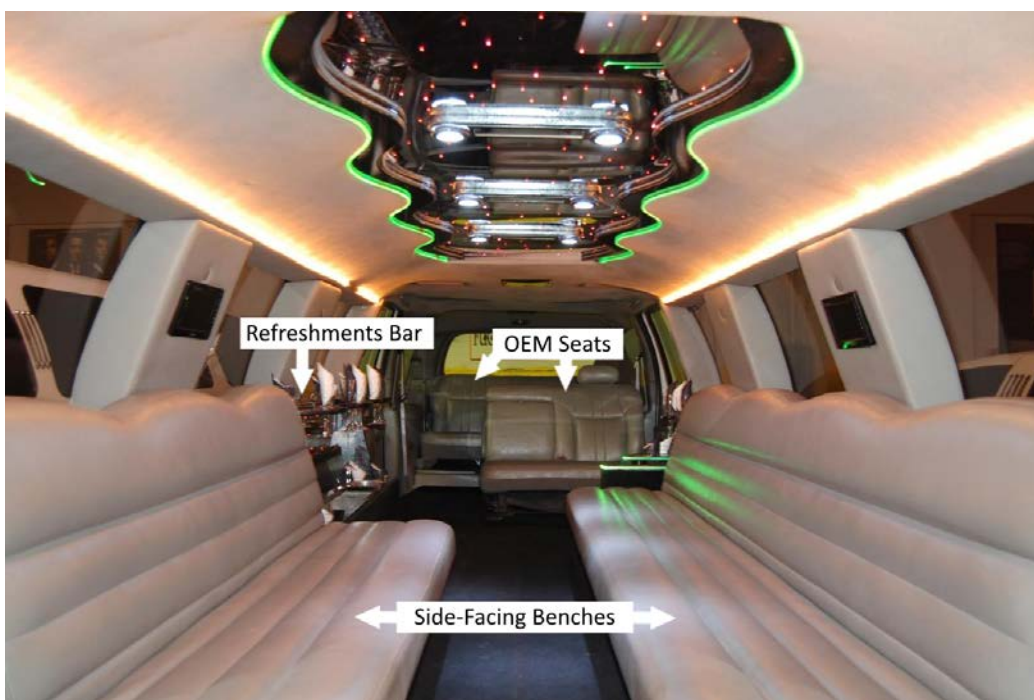
Figure 4. A 2010 photograph of the limousine’s interior, looking from the front of the vehicle toward the rear of the passenger compartment. (Courtesy of the previous owner, Advantage Transportation Group)

The three non-OEM bench seats were equipped with passenger lap belts; the OEM seats retained their original lap/shoulder belts on the outboard seats and lap belts on the middle seats. According to a NYSDOT vehicle examination report, the vehicle’s total seating capacity was 18 occupants.⁶ The NTSB’s postcrash inspection of seat belt anchor points indicated 21 belted seating positions in the vehicle. NTSB investigators noted that the seating positions available in the vehicle could range from 18 to 22, depending on how a position is defined.⁷ On the day of the crash, all 17 limousine passengers were seated within the passenger compartment. Evidence from first responders and postcrash examinations of victims indicated that none of the passengers were wearing the passenger lap or lap/shoulder belts at the time of the crash.⁸
